Smoke and Dye Testing Summary

High Level Sewershed

Test ID	Test Type	Date Inspected	Company / Super.	Blower MH	Ground Condition	Notification Made?	Total Length
S1028-058	Smoke	9/8/2008	ADS/TM	S13EE1016MH	Dry	Yes	1,545.58

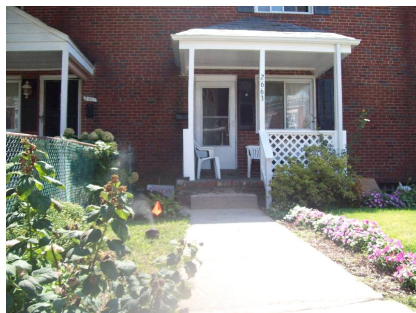
Picture \S1028-058-OB01-P01.jpg

Comments Smoke from cleanout in front yard. 2663 Oswego Ave

Comments Front of house, 2663 Oswego Ave

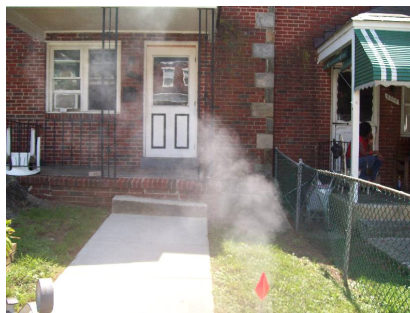
Picture \S1028-058-OB02-P01.jpg

Comments Smoke from cleanout in front yard. 2657 Oswego Ave

Comments Front of house, 2657 Oswego Ave

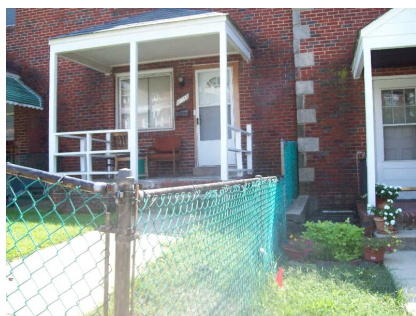
Picture \S1028-058-OB03-P01.jpg

Comments Smoke from cleanout in front yard. 2653 Oswego Ave

Comments Front of house, 2653 Oswego Ave

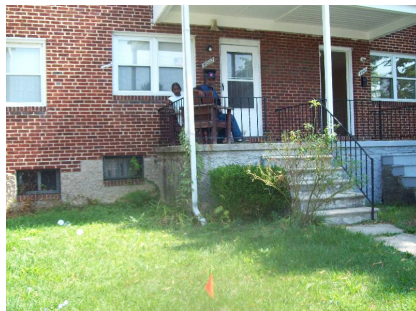
Picture \S1028-058-OB05-P01.jpg

Comments Smoke from cleanout in front yard. 4007 Pimlico Rd

Comments Front of house, 4007 Pimlico Rd

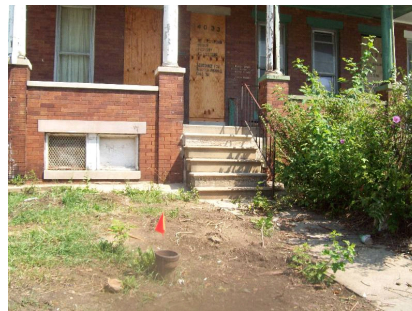
Picture \S1028-058-OB06-P01.jpg

Comments Smoke from cleanout in front yard. 4033 Park Heights Ave

Comments Front of house, 4033 Park Heights Ave

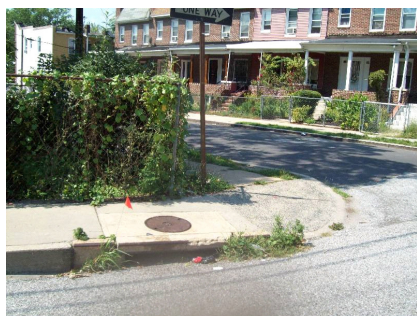
Picture \S1028-058-OB07-P01.jpg

Comments Smoke from catch basin along curb at SW corner of Oswego Ave & Pimlico Rd

Comments Oswego Ave & Pimlico Rd looking west

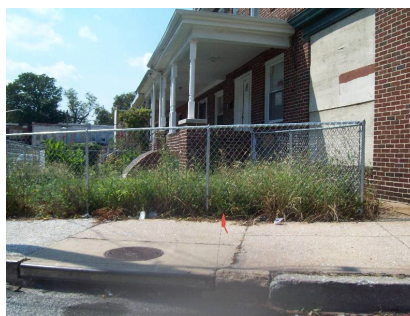
Picture \S1028-058-OB08-P01.jpg

Comments Smoke from catch basin along curb at NW corner of Oswego Ave & Pimlico Rd

Comments Side of house, 2658 Oswego Ave
